## ADVISORY CIRCULAR

43-16A

# AVIATION MAINTENANCE ALERTS

**ALERT  
NUMBER  
379**

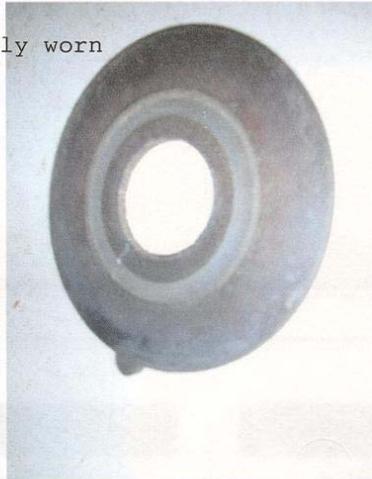
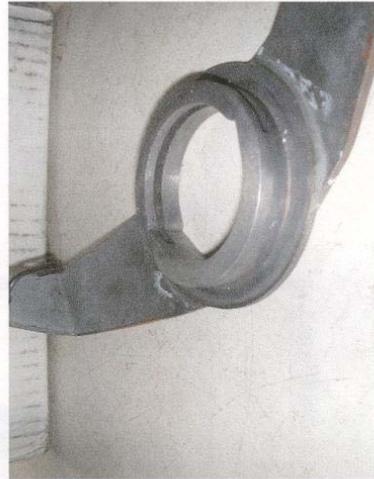
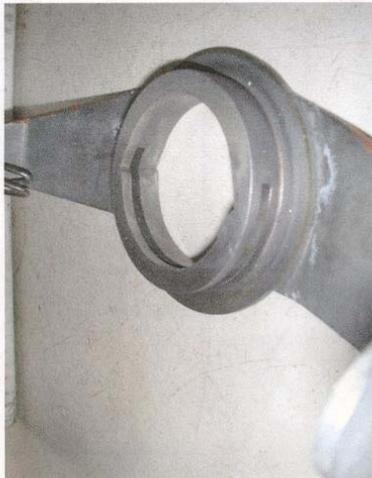
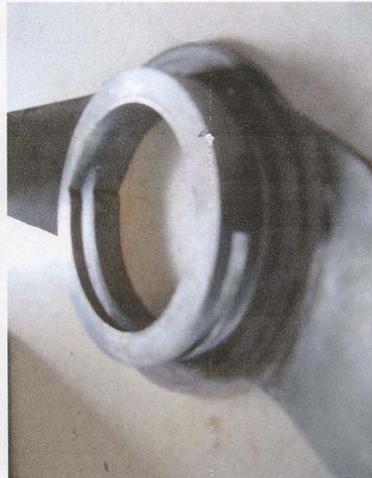
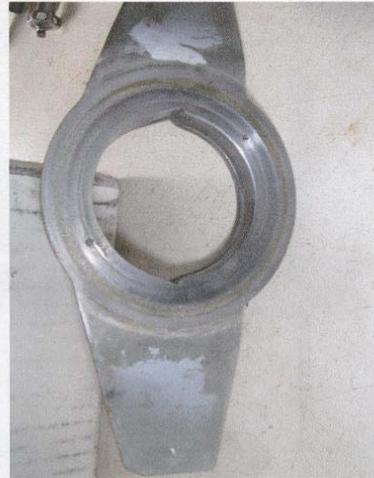
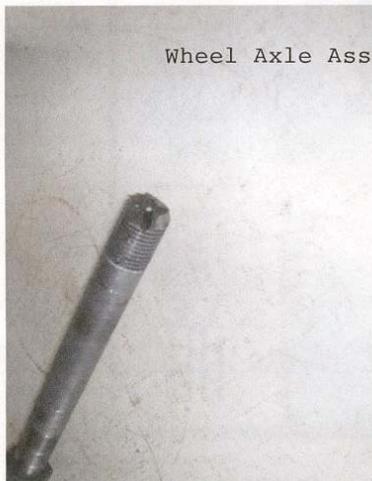
"During an annual inspection, it was noted that the tail wheel could not be steered," says this mechanic. "The tail wheel had been painted in the past (*as*) the top grease fitting was completely (*covered*). The aircraft owner stated (*a previous mechanic*) who had worked on the aircraft in the past told him not to grease the tail wheel, and to tighten the nut on the bottom of the steering bolt as tight as possible. Disassembly revealed all parts inside the tail wheel unit were extremely worn. The pins that should have been attached to the thrust plate were missing. Additionally, the axle for the tail wheel had been damaged previously, and the end of the axle was partially ground off—(*extending*) through the hole for the cotter pin (*used*) to secure the nut on the end of the axle. The entire tail wheel was beyond repair and was replaced with a serviceable (*unit*)." (*Part name and number: Scott 3200.*)

Thrust Washer severely worn

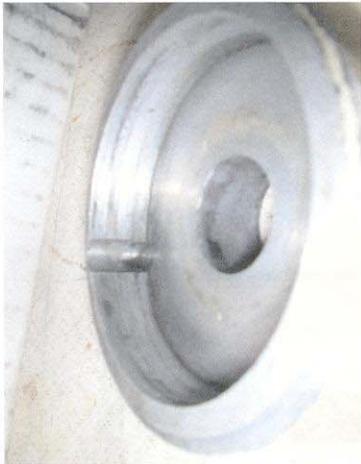
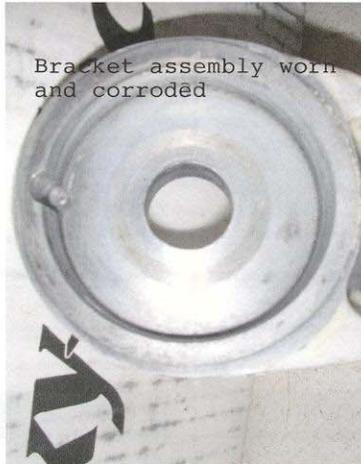
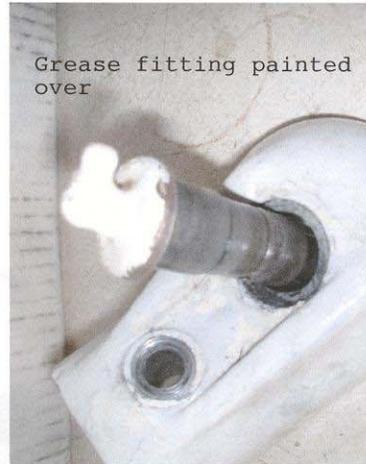
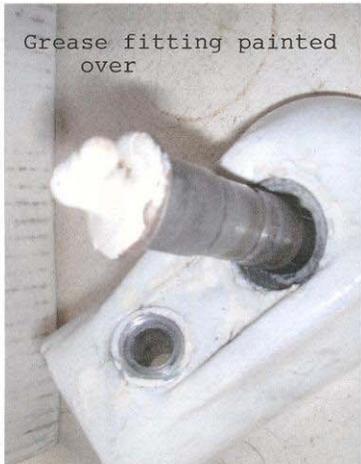
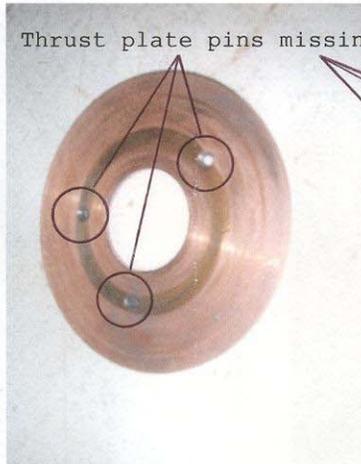
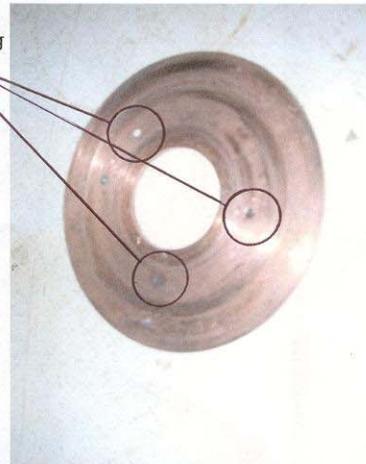
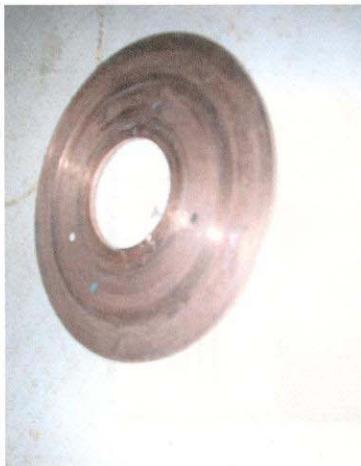
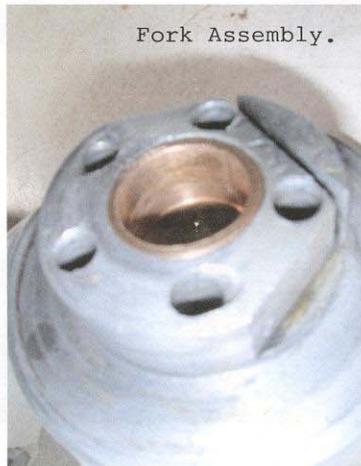
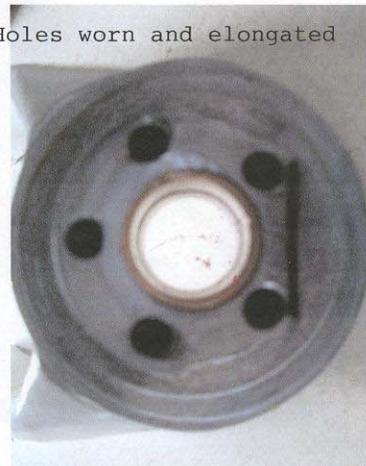
Tailwheel

Wheel Axle Assembly Threaded end damaged. Not possible to safety

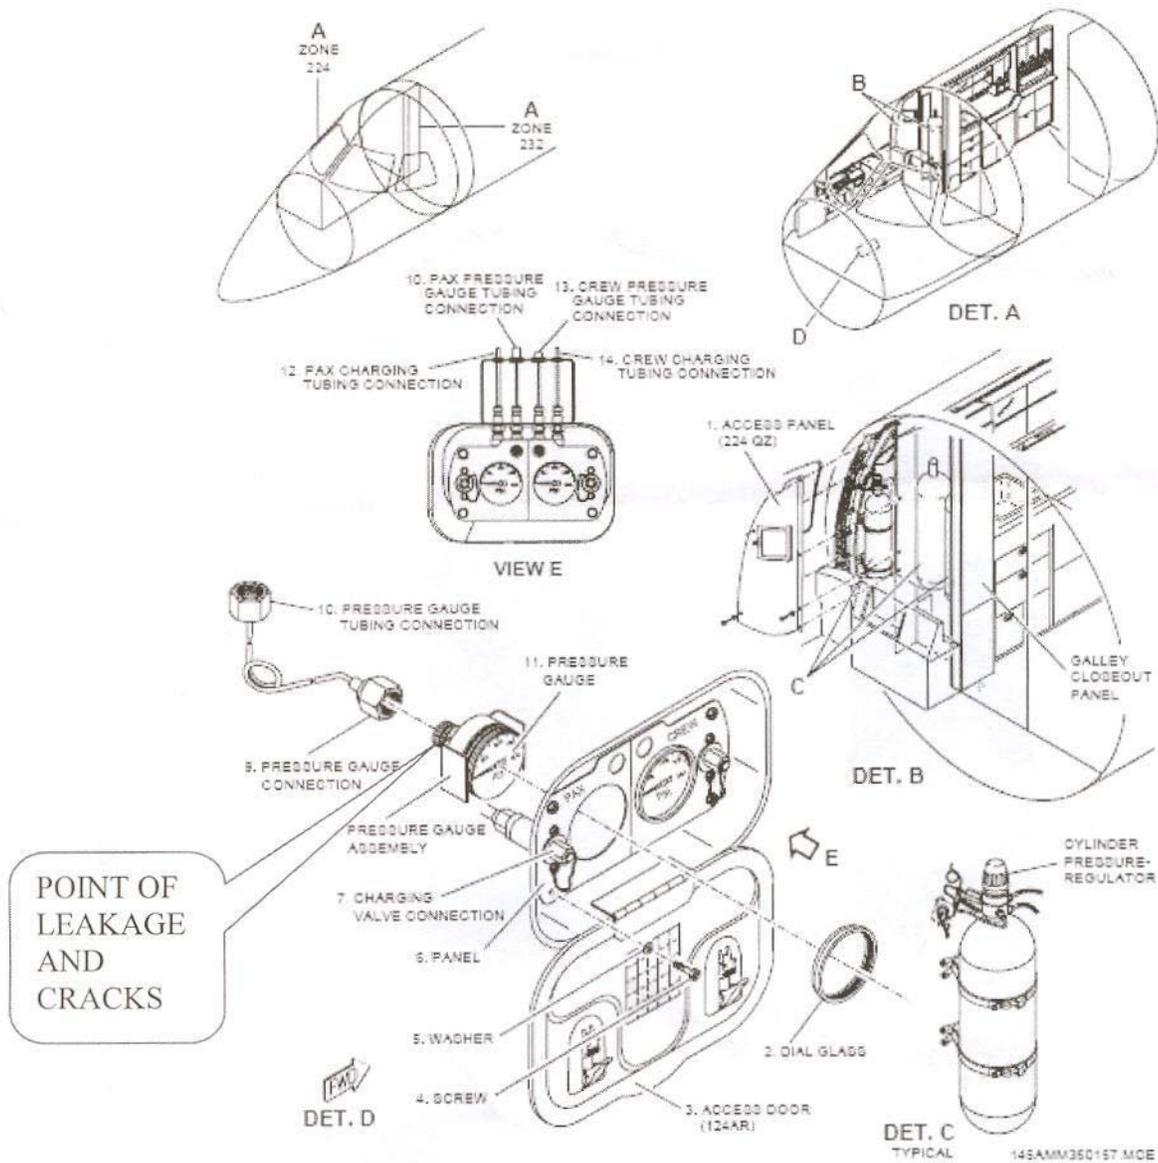
Pressure Gauge Assembly - Removal/Installation  
Figure 401

"Replacement items were ordered from the manufacturer (Embraer) for defect (*resolution*). Upon receipt (*of a new*) replacement gage assembly (P/N 171013), an identical crack was found on fitting (P/N 500189)—the gage was rejected." "The cause of cracking can not be positively (*identified*), but it may be due to over-torquing of the fittings to the gage."
