**Federal Aviation  
Administration**

## ADVISORY CIRCULAR

# AVIATION MAINTENANCE ALERTS

**ALERT  
NUMBER  
372**

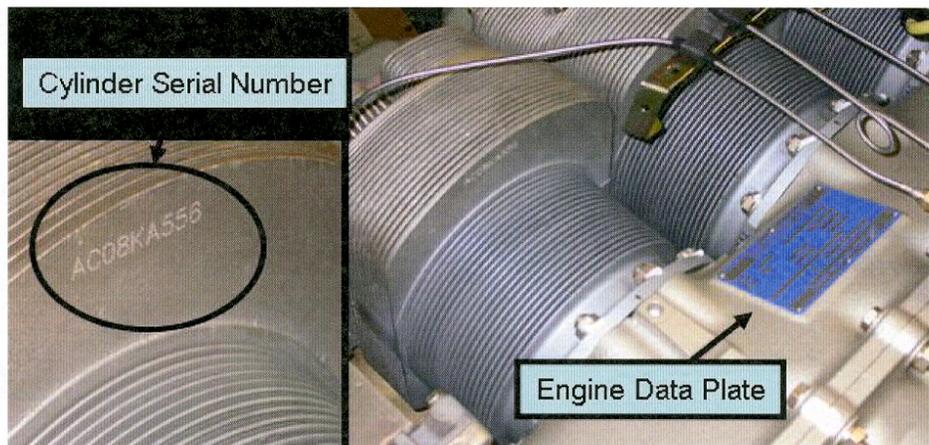
**FIGURE 3**  
**Cylinder Serial Number and Engine Data Plate Locations**

Inspect all potentially affected cylinders, within the next twenty (20) flight hours, but no later than April 30, 2009. Verify affectivity of all engine models and cylinders in accordance with Tables 1, 1A, 2, and 2A and the MODELS AFFECTED section. The engine serial number is located on the engine data plate and the cylinder serial number is located on the crankcase side of the top portion of the cylinder head as installed on the engine (Reference Figure 3).

- c. If a number casting mark **is not** present, then the cylinder may be covered by this MSB. Verify the EQ3 cylinder S/N as shown in Figure 3 is present and listed in Table 2. If so, proceed to completion and registration and **STEP 2**.

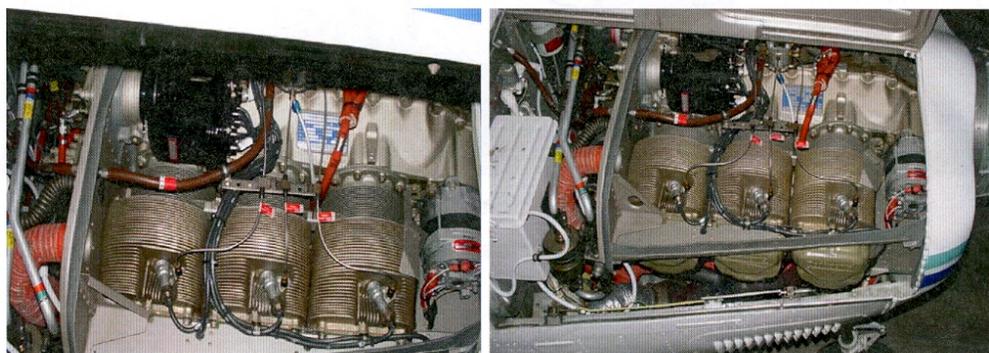
**FIGURE 4**  
**Example of Top Down View with Cowling Removed**  
**Typical Engine Installation**

1. Open or remove the engine cowling in accordance with the airframe manufacturer’s instructions to the point necessary to allow visual access to the cylinders on both sides of the engine (Figure 4).

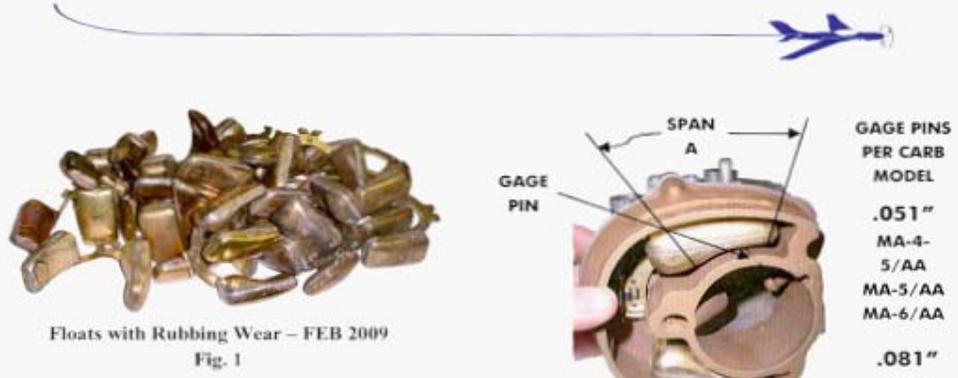
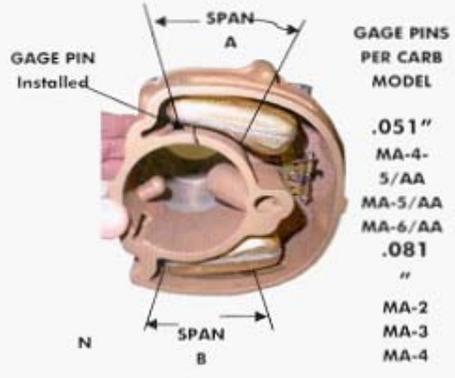
With the clearance tool M-510 or M-513 (dependent on model) in place, orient the carburetor body with one pontoon uppermost, see Figure 2. Check the clearance between the float pontoon and the bowl wall. A .081 inch gage pin (models MA-2, MA-3 & MA-4), or a .051 gage pin (models MA-4-5, MA-4-5AA, MA-5, MA-5AA, MA-6 and MA-6AA) must pass between the lower surface of the upper pontoon and the throttle bore wall and between the lower surface of the lower pontoon and the lower bowl wall without touching either pontoon. Reorient the carburetor so that the other pontoon is uppermost, see Figure 3. Repeat the clearance check. If, as the gage pin is moved along between the float and the bowl wall the gage pin contacts either pontoon, float clearance is inadequate and the float assembly must be replaced.
