ADVISORY CIRCULAR

43-16A

AVIATION MAINTENANCE ALERTS

**ALERT
NUMBER
384**

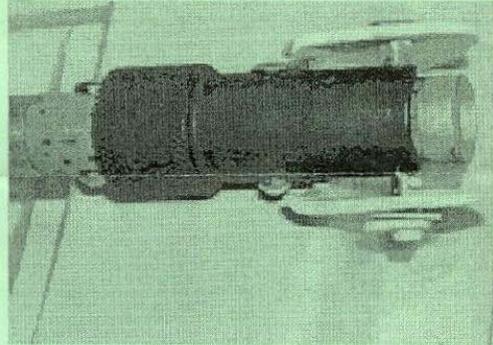
Figure 3. Verrou principal bien inséré

1. le verrou principal s'est bien inséré dans sa goupille de serrage sur le capotage du noyau central, comme l'illustre la figure 3;

It is essential that all defined procedures found in Aircraft Maintenance Manual (AMM) 71-12-01-410-802, Temporary Revision (TR) 71-137 are followed, ensuring that:

1. The primary lock has properly engaged its clip pin on the core cowl door as seen in figure 3;

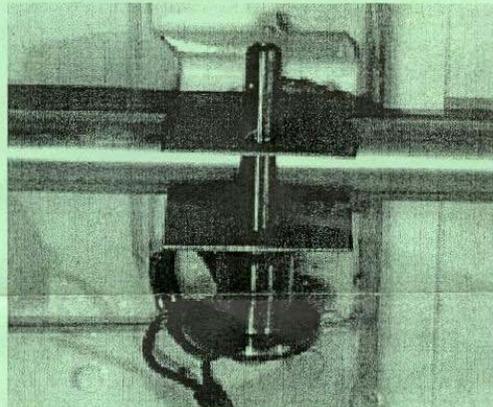
Figure 4. Goupille du verrou secondaire bien installée, capotage du noyau central en position ouverte

2. la goupille du verrou secondaire du support est bien orientée, comme l'illustre la figure 4.

Il importe de remarquer que la goupille du verrou secondaire est inversée (pointe vers le haut), comme l'illustre la figure 4, lorsque le capotage du noyau central est ouvert, comme c'est habituellement le cas pendant les activités de maintenance, mais qu'elle est à l'endroit (pointe vers le bas), lorsque le capotage principal est fermé. Le MMA, lequel était erroné avant la RT 71-137, a été corrigé afin de préciser ce fait important concernant la goupille.

2. The stay support strut/rod secondary lock pin is correctly oriented as seen in figure 4;

Note that the secondary lock pin will be inverted (pin pointing up) as seen in figure 4 when the core cowl is open, as normally seen during maintenance activities but will be positioned (pin pointing down), with the core cowl in the closed position. The AMM has been corrected, which was in error prior to TR 71-137, to stipulate this important pin configuration.

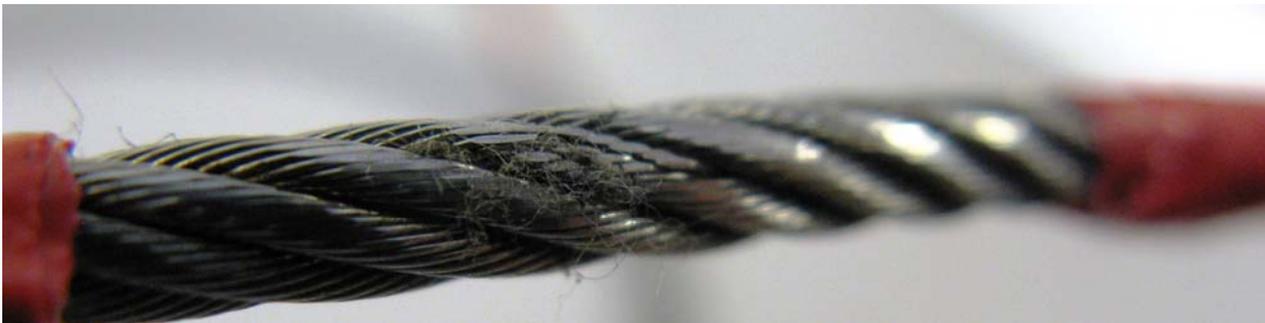
Left arrow shows location of wear. Rt. Arrow is where cable is attached to rudder Bellcrank.
