ADVISORY CIRCULAR

43-16A

AVIATION MAINTENANCE ALERTS

**ALERT
NUMBER
338**

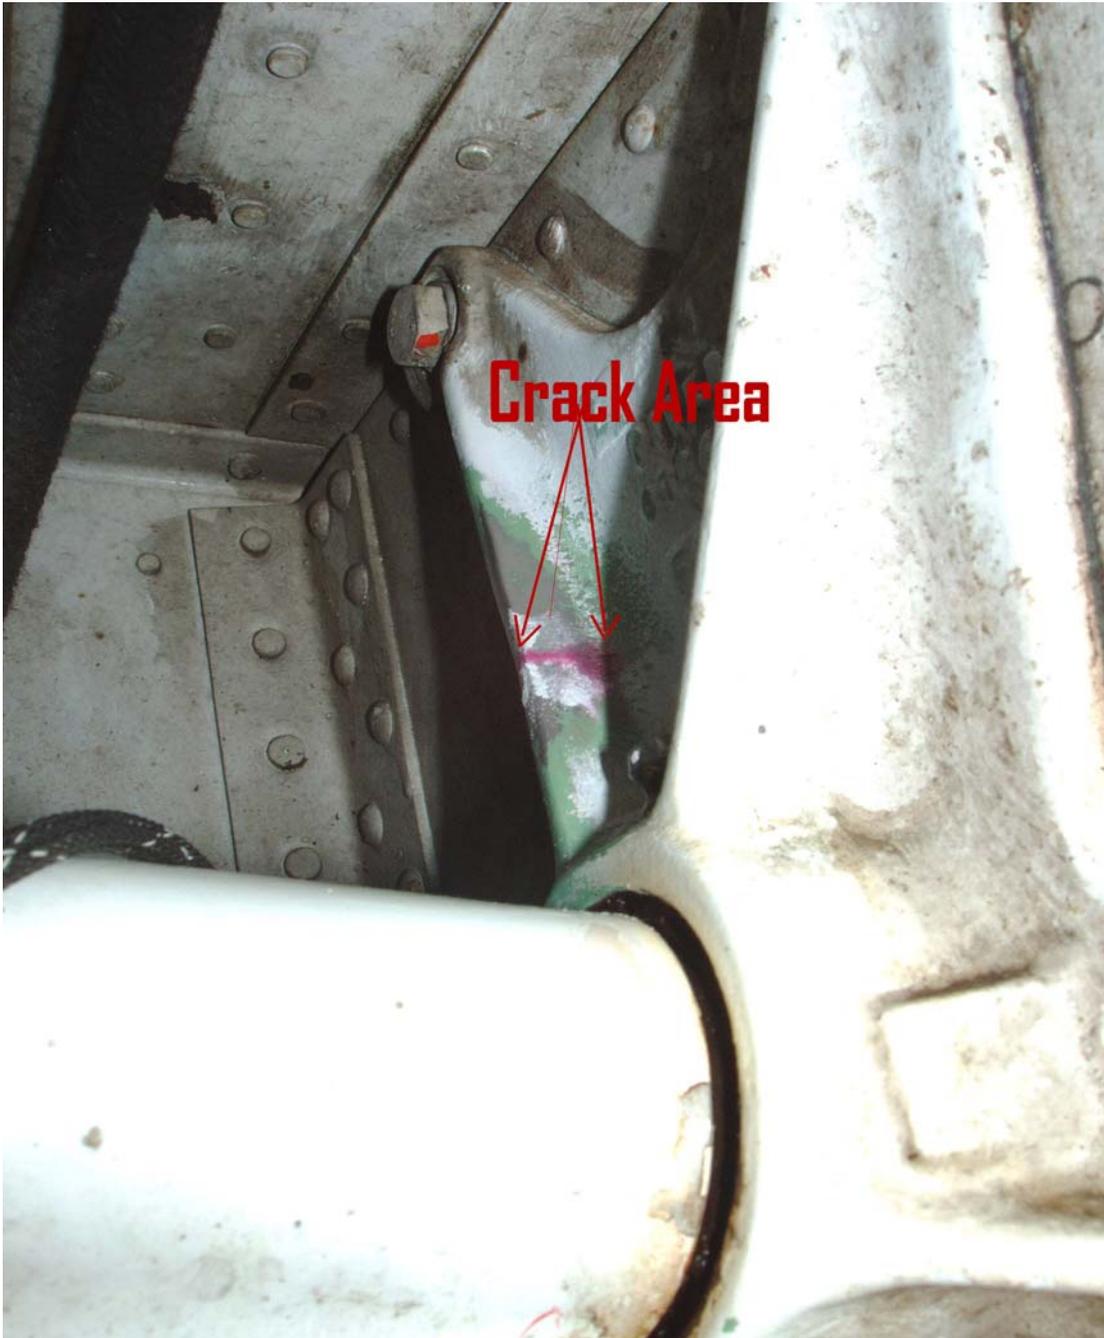
The original M or D (*malfunction or defect*) report as submitted by the part 145 repair station reads, “During maintenance inspection of the landing gear, the mechanic (*Jesse Hanson*) found the aft (*R/H*) main gear trunnion cracked. Dye penetrant (*chemical testing*) confirmed the crack. The cause is undetermined, (*however*), the aircraft is used in flight training (*Trunnion P/N 67042013*).”
